TO: TECHNICAL SERVICES COMMITTEE – MONDAY 11 MARCH 2013

SUBJECT: TOWN CAMPS REPORT UPDATE

Trucking Yard – Site visit notes

Inspection Report on Trucking Yards, Larapinta Valley and Hidden Valley Community Road Pavements

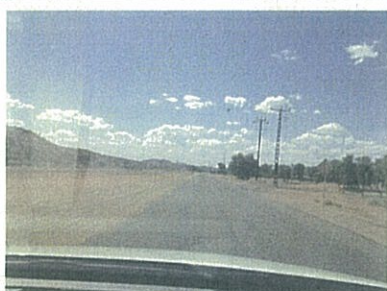
Smith Street looking West.

- Intersection still not upgraded.
- Road signage damaged.
- Traffic management – does not exist.

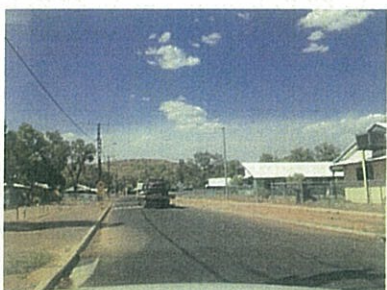
Entrance Road into Camp.

- Significant silt on road
- Dust stains indicates possible ponding of stormwater due to poor grading.

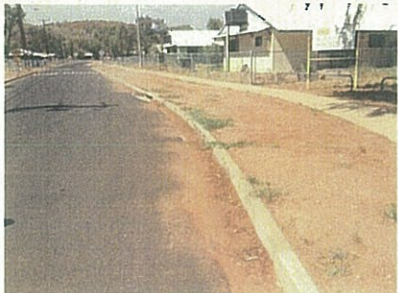
<p>Entrance Road into Camp. Same issues as above</p>

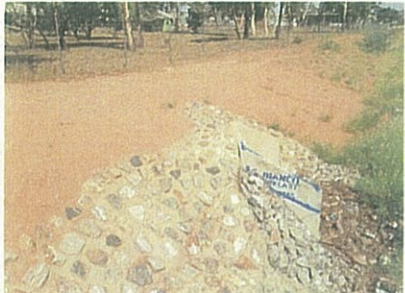
<p>Stormwater outlet at Smith Street Open Drain</p> <ul style="list-style-type: none"> • Not Maintained/cleaned • Construction not consistent with materials • Suggest that this headwall has been constructed as an afterthought and has not been designed.

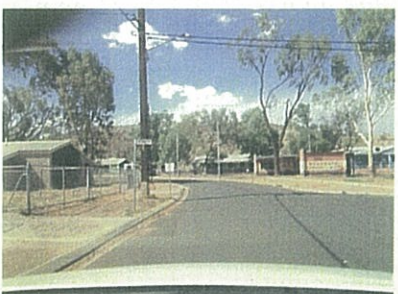
<ul style="list-style-type: none"> • No Through road signage damaged and not stable. • Silt on gutters.

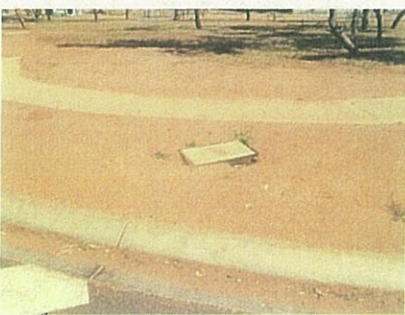
<ul style="list-style-type: none"> • Erosion around Telstra pit • Indicates verge is not compacted at service pit locations or pipes have been damaged.

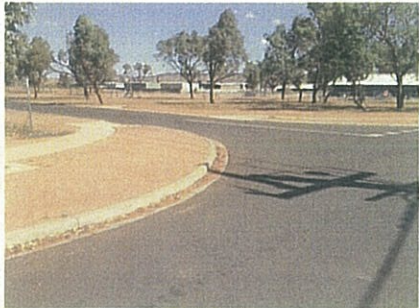
<ul style="list-style-type: none"> • This kerb return is in a low spot with no drainage. • Silt around kerb and gutter is going to be an on-going issue for maintenance.

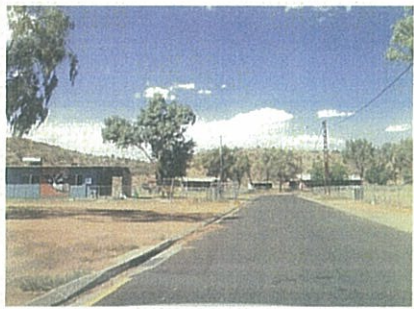
<ul style="list-style-type: none"> • Silt issues. • Stormwater tray in front of SEP not constructed correctly – this leads to localised ponding. This issue is consistent across the camps

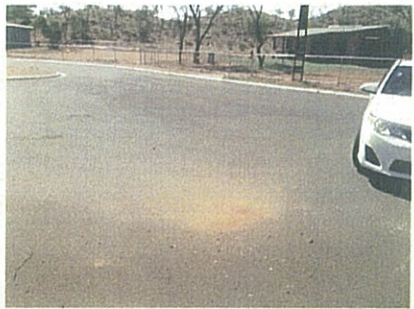
<p>Asphalt/pavement issues – refer separate notes from BB Civil.</p>

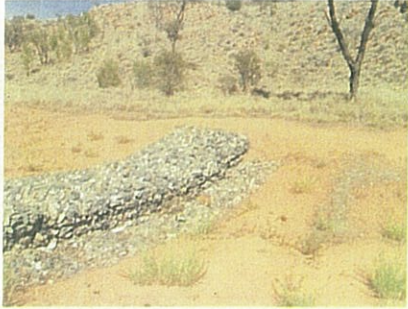
<p>On-going erosion issues as had been suggested in previous report.</p>

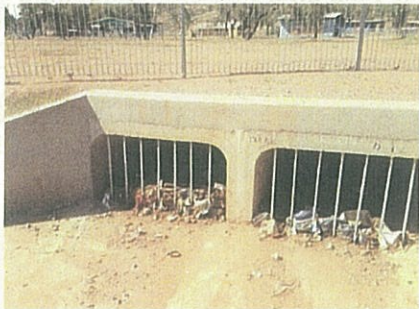
<p>Un-maintained underground drainage outlet</p> <ul style="list-style-type: none"> • Not possible to maintain due to access issues – poor design/construction.

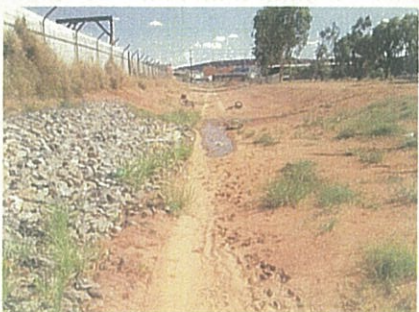
<p>Open Channel on eastern boundary.</p> <ul style="list-style-type: none"> • Concrete low flow channel is completely filled with silt. Embankment stabilisation would have resolved much of this issue.

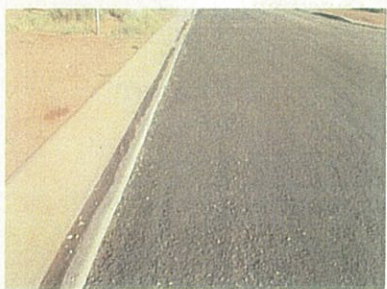
<p>Kerb type is not as per council's requirement Road Grade is an issue – not adequately graded to allow stormwater flow.</p>

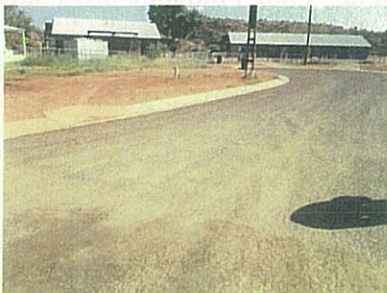
<p>Primer Seal has been installed on most of the roads but not all. Refer to BB Civil comments. Kerb Ramp (in foreground) appears to be a flat spot and holding silt. Kerb Ramp is also non-compliant to Australian Standards.</p>

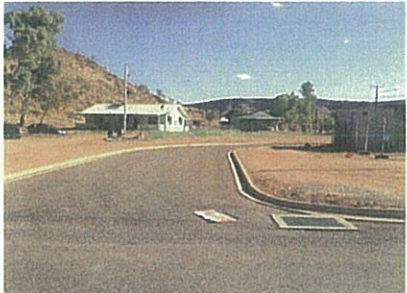
<p>A stormwater pit is located within the road carriageway – This is not acceptable in the driveline for vehicles.</p> <p>Localised grading appears to be an issue although an attempt has been made to manage this via the stormwater pit.</p>

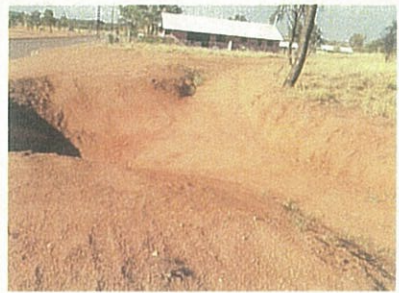
<p>Stormwater Channel – looks like a path leading to a road crossing. Batter is too steep and is considered unsafe.</p> <p>Existing tree root have been removed and is will have an impact on the existing tree survival.</p>

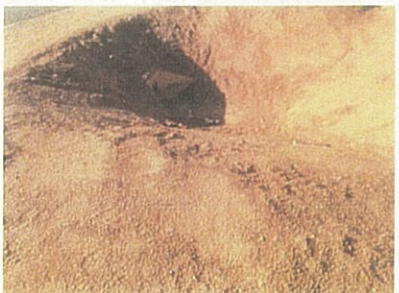
<p>As above.</p> <p>Road safety and pedestrian safety issue.</p>

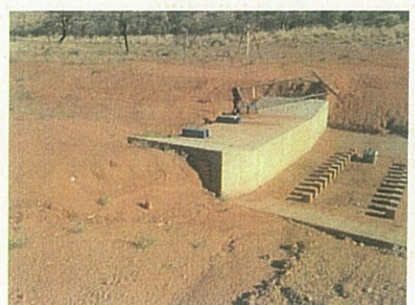
<p>Stormwater drop structure</p> <ul style="list-style-type: none"> • Erosion issues • Design has not considered existing soil types and lack of vegetation • Safety issues (after hours) has not been considered

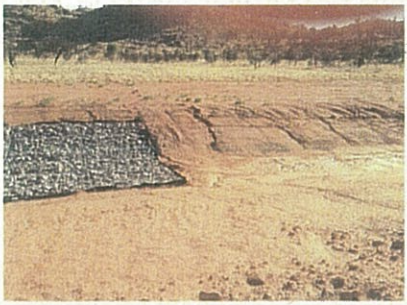
<p>Stormwater – Major channel</p> <ul style="list-style-type: none"> • Channel works not complete • Erosion issues

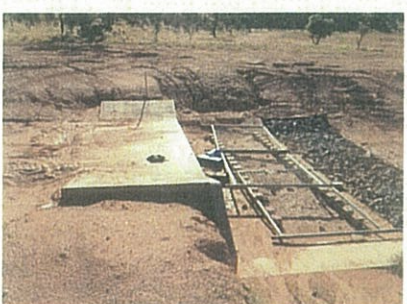
<p>Stormwater drop structure</p> <ul style="list-style-type: none"> • Erosion issues • Design has not considered existing soil types and lack of vegetation • Safety issues (after hours) has not been considered

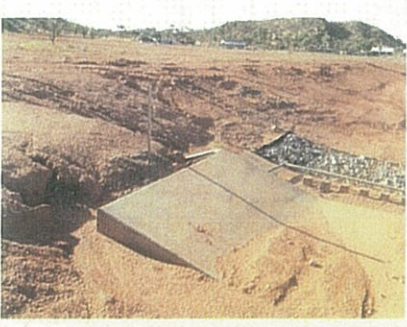
<p>Stormwater drop structure</p> <ul style="list-style-type: none"> • Erosion issues • Design has not considered existing soil types and lack of vegetation • Safety issues (after hours) has not been considered

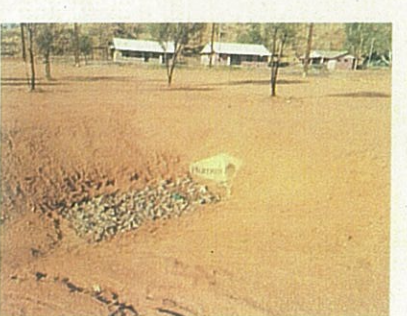
<p>Stormwater outlet</p> <ul style="list-style-type: none"> • Safety concerns • Erosion issues

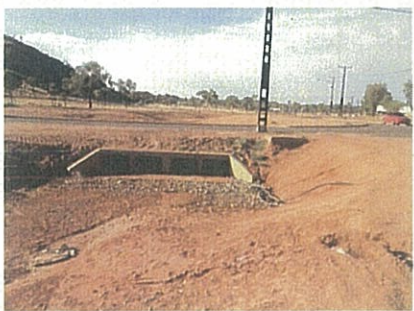
<p>Stormwater Channel crossing</p> <ul style="list-style-type: none"> • Safety issue with traffic • Significant erosion issues

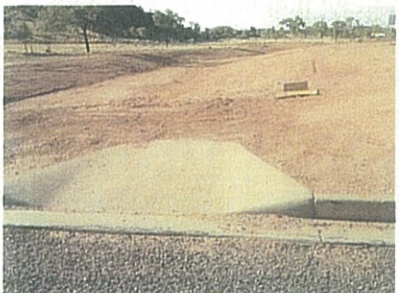
<p>Kerb ramp Does not comply to Australian Standards</p>

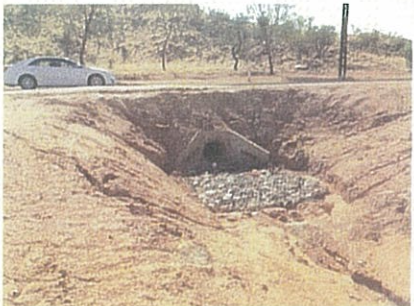
<p>Stormwater outlet</p> <ul style="list-style-type: none"> • Road safety concerns • Erosion issues

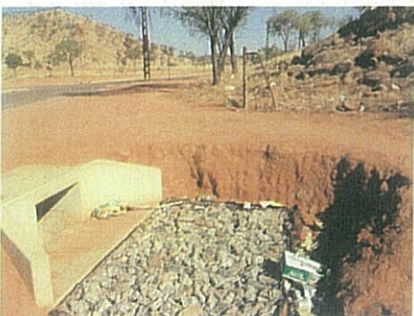
<p>Stormwater inlet</p> <ul style="list-style-type: none"> • Batter too steep • Safety concerns • No Safety bars to inlet structure

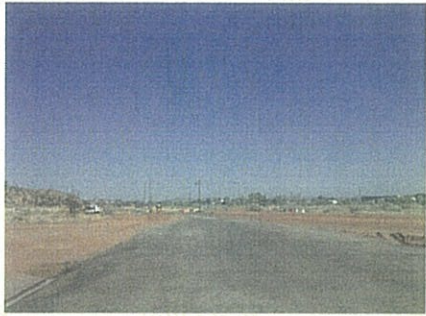
Road entrance to the Camp

- Roadworks is incomplete
- No kerbs or stormwater infrastructure

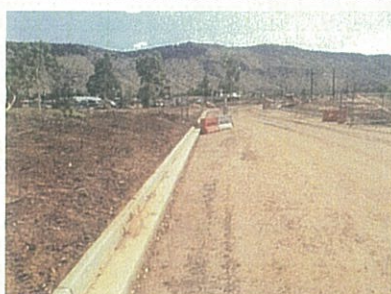
Road under construction
It appears that the kerbs have been constructed over thin layer or compacted (?) quarry rubble. There is no evidence of sub-base being constructed in the road.

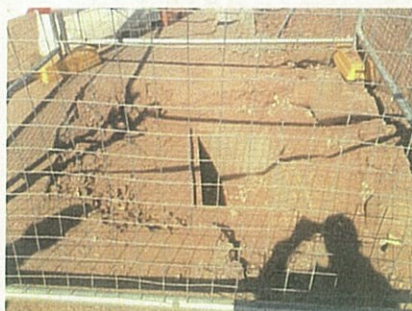
Stormwater pit
Significantly blocked with silt
Top level appears to be below existing surface level.

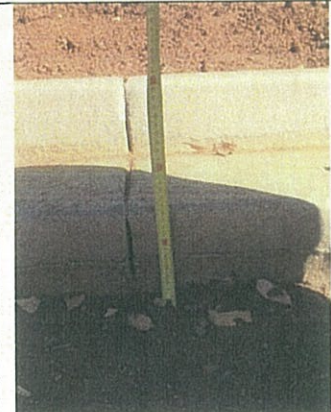
<p>Kerb throat depth noted at 130mm at some locations – Minimum requirement as per Australian Standards – 150mm at Gutter. This means that the edge should be 175mm minimum.</p>

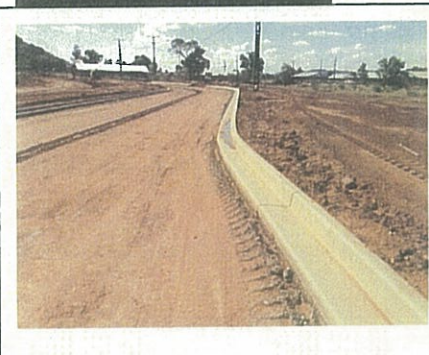
<p>Kerb has low spots (multiple locations) This will require reconstruction of significant lengths to fix the issue.</p>

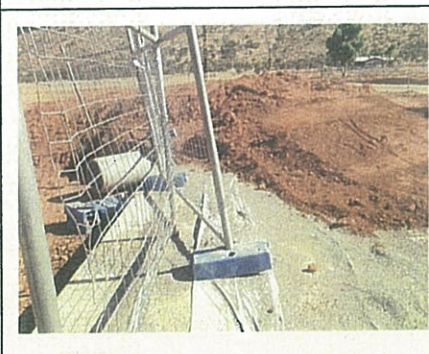
<p>Culvert Crossing These have been constructed recently. It does not have seals between the "crowns".</p>

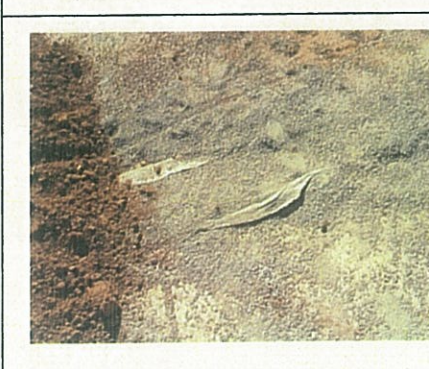
<p>As above</p>

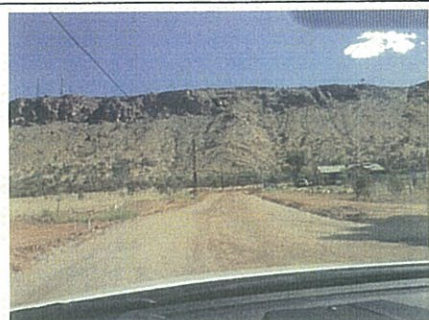
Road still under construction – at Sub-grade stage.

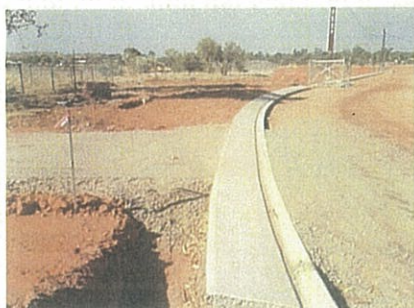
Kerb type is not line with council standard.

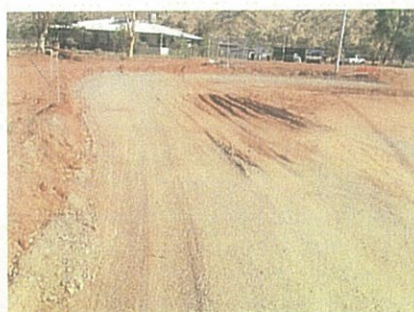
Quarry rubble being placed under kerb.
Note the existing sub-grade under pavement is wet and will be an issue with pavement.

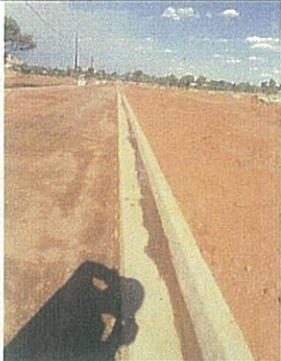
<p>Kerb is ponding water This section should be removed and re-graded.</p>

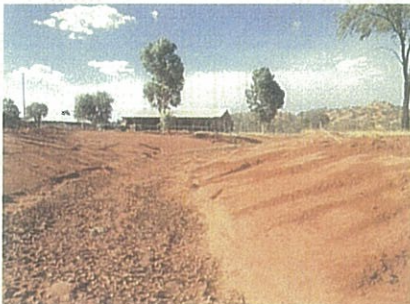
<p>Silt issues in stormwater open channel</p>

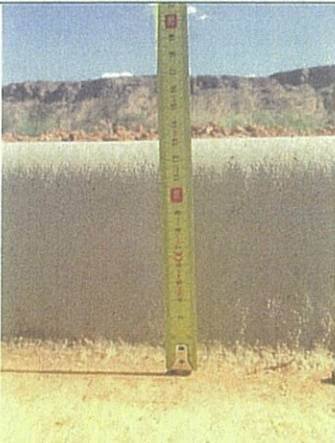
<p>Barrier kerb height. This kerb is required to be 150mm high, currently built to 130mm.</p>

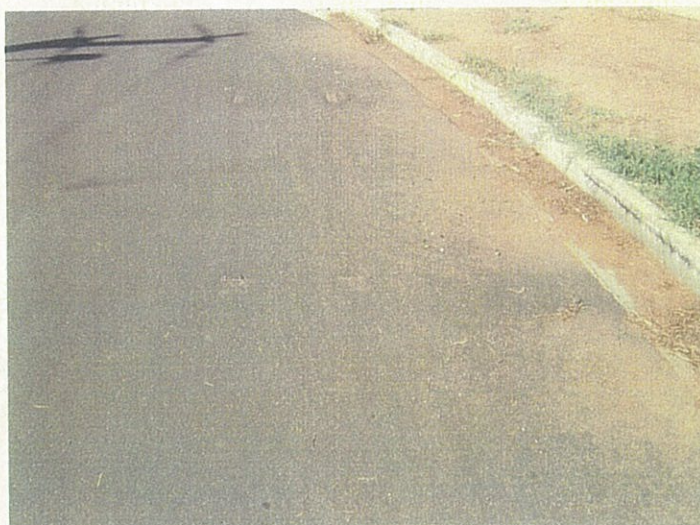
- Minor environmental cracking of the asphalt surface noted
- Surface damage (indentations) caused by an object placed on the asphalt road surface
- Surface damage (indentations) where loose stones have been punched into the asphalt surface under vehicle loads
- Surface damage due to vehicle tyre marks on soft asphalt mix
- Surface damage (shoving and ravelling) of the asphalt surface due to turning vehicle tyres while the vehicle is stationary and breaking of vehicles
- Loss of fines from the asphalt surface under turning vehicle tyres in cul-de-sacs.
- Some areas of open texture suggestive of lower compaction levels or low mix temperatures
- Loss of surface fines due to adhesion to vehicle tyres

The above may indicate the use of a softer grade of bitumen or some softening of the bitumen due to diesel or kerosene contamination.

Asphalt surface damage - indentations

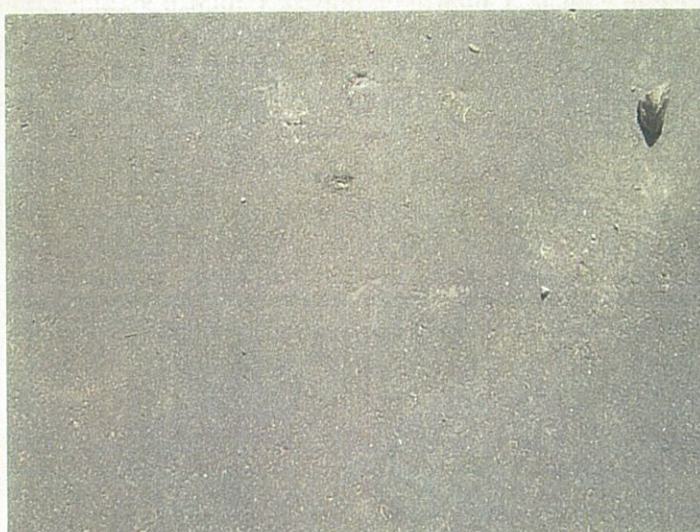
Asphalt surface damage - indentations

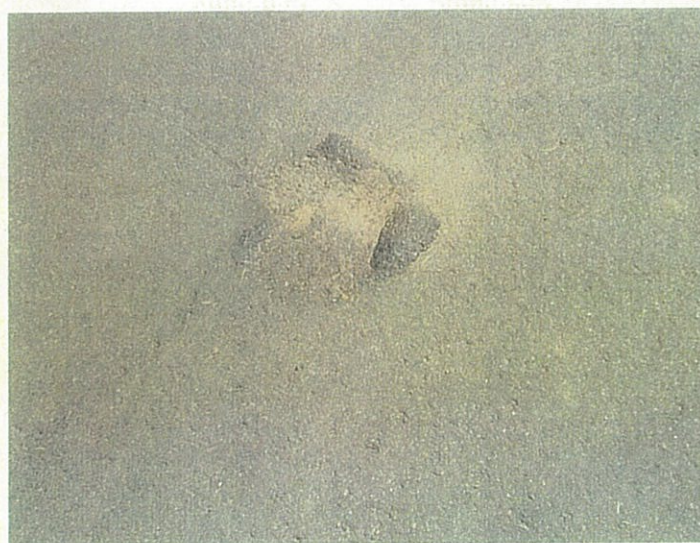
Asphalt surface damage - turning vehicle wheel

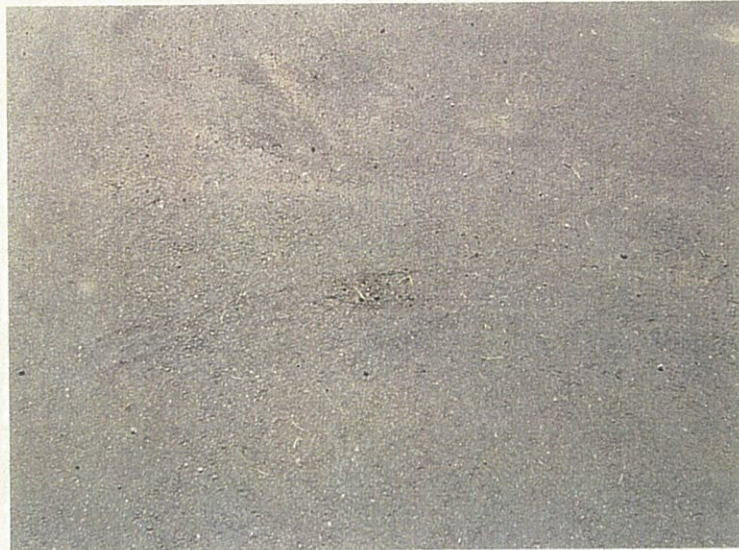
Asphalt surface damage - tyre damage and wheel marks

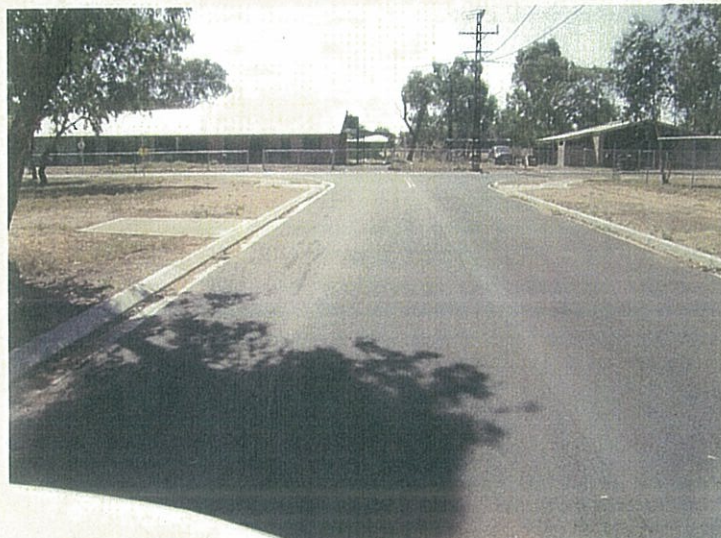
Asphalt surface damage - tyre damage and wheel marks

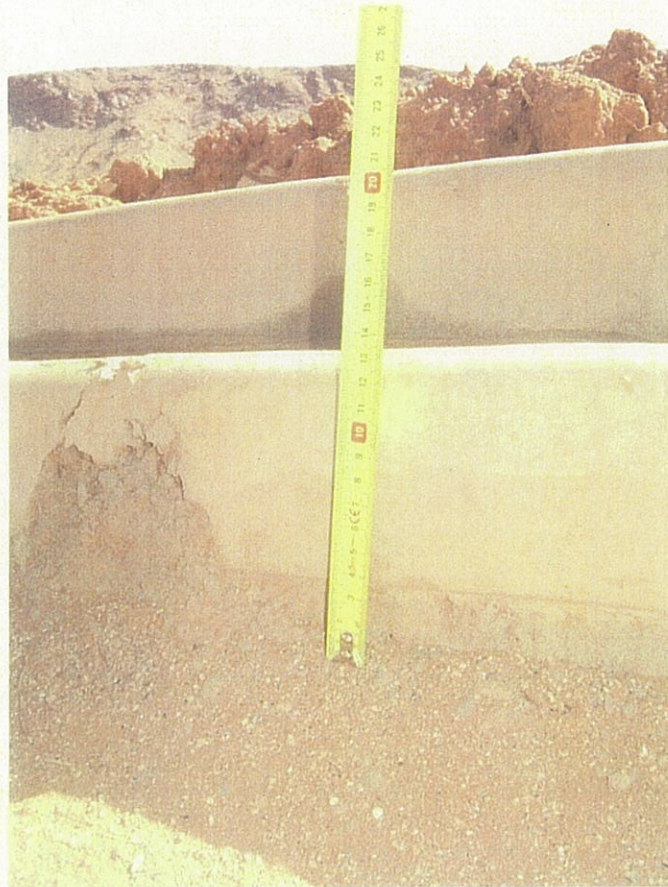
- Water table edge depths measured to be 135mm - 160mm, inferring a similar pavement depth, including the asphalt surface.
- Surface preparation of the earthworks indicates only one crushed granular pavement layer in the pavement structure, both on collector roads and local/minor roads.
- The Cardno pavement design recommends 150mm basecourse plus 25mm basecourse (175mm total depth) on CBR 15% subgrades.
- No granular founding layer placed for the concrete kerbing
- Silty fines noted for some areas of subgrades which had become weak due to watering

Shallow kerb water table depth

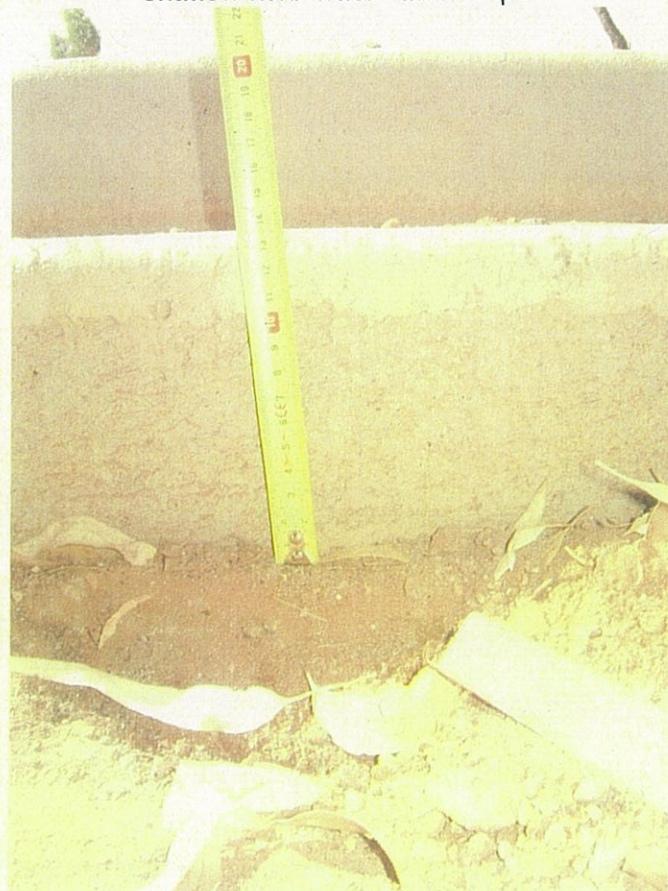
Shallow kerb water table depth

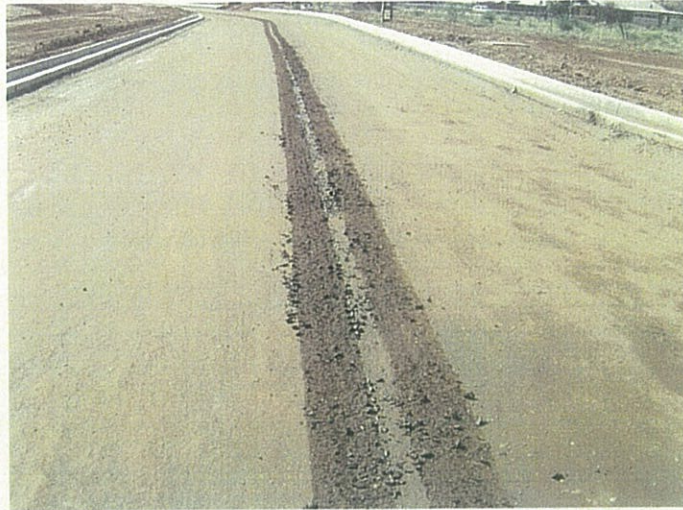
Tackiness of silty fines on wet earthworks

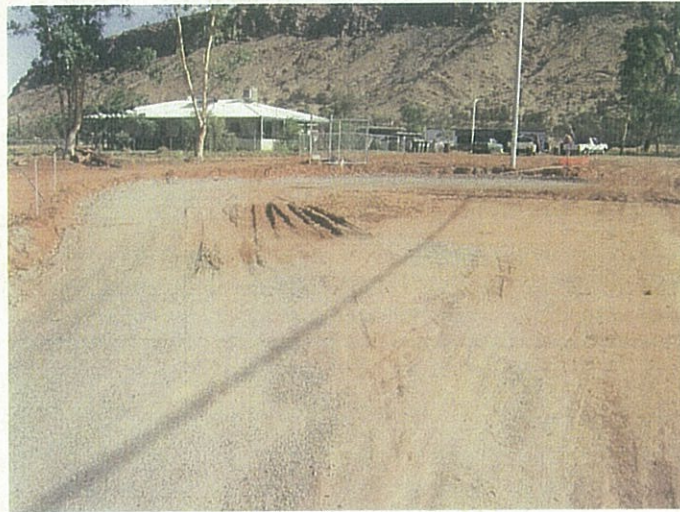
Weak soils when wet

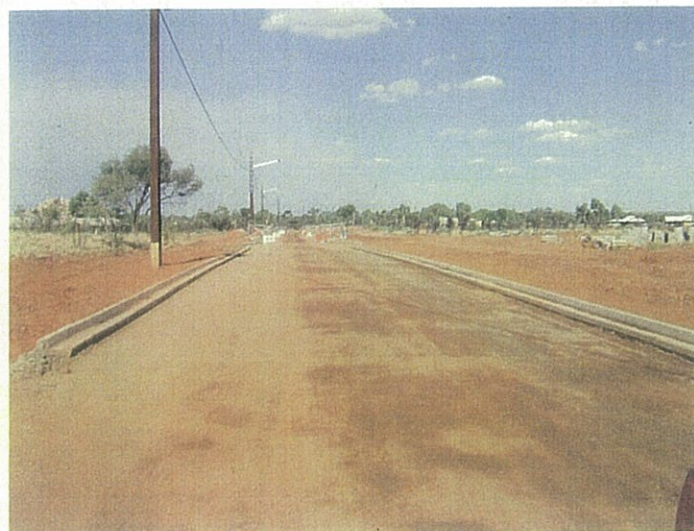
Consistent kerb depths

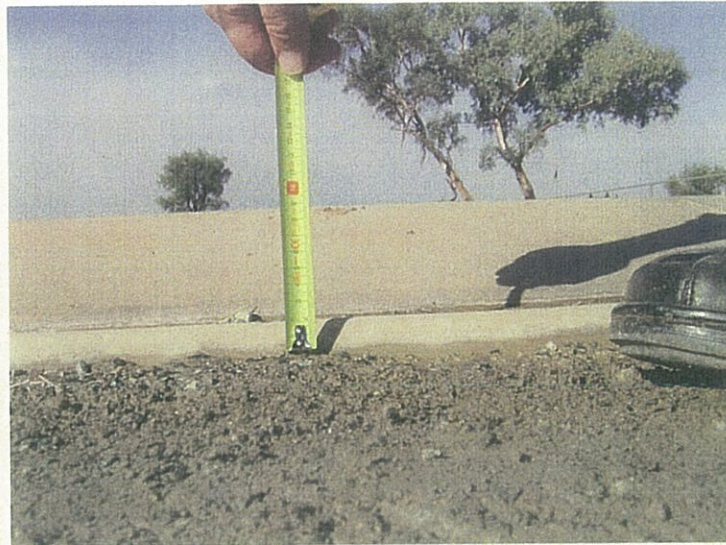
- Basecourse placed throughout with primer seal placed on most areas of completed base.
- Depth of water table above basecourse or primer seal noted was 20mm - 40mm. This implies a basecourse depth of 120mm - 150mm.
- Localised minor stripping of the primerseal possibly due to a blocked jet on the bitumen sprayer
- Localised minor bleeding of the primerseal due to embedment of the sealing aggregate in the basecourse surface
- Some areas of damp basecourse visible where primerseal not yet applied
- Application rate for primerseal mostly looks adequate, with some over application of sealing aggregate. In some areas there is a build-up of surplus sealing aggregate in the gutter, but this should normally be swept off prior to application of asphalt.

Depth to top of water table from basecourse for asphalt surface - 20mm

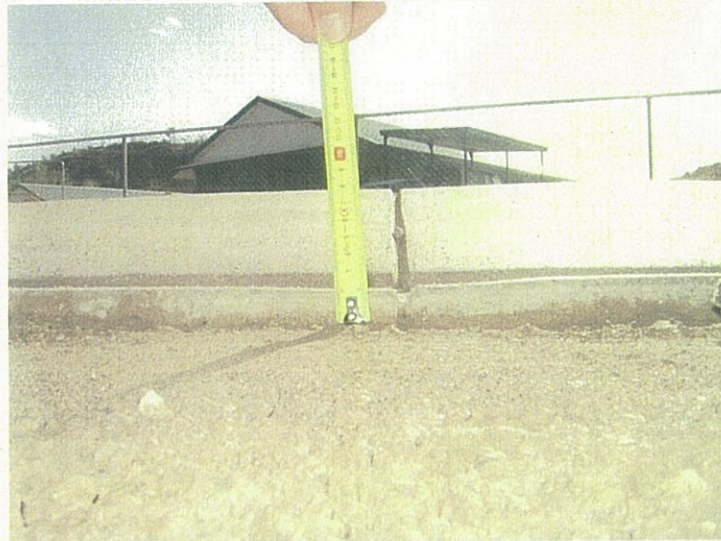
Depth to top of water table from basecourse for asphalt surface - 20mm - 25mm

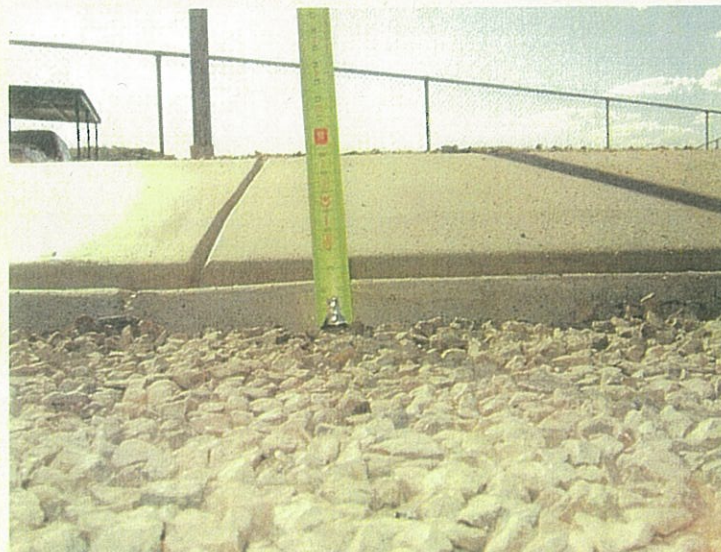
Depth to top of water table from primerseal for asphalt surface - 25mm

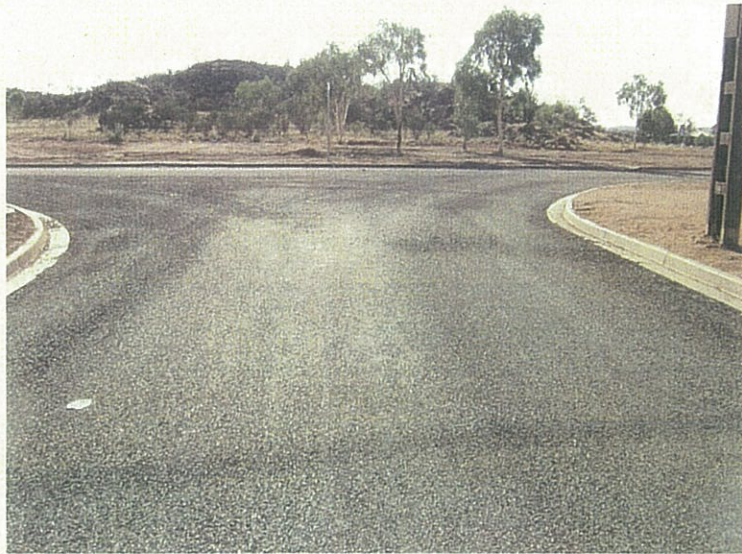
Minor localised bleeding of primerseal due to aggregate embedment in soft base

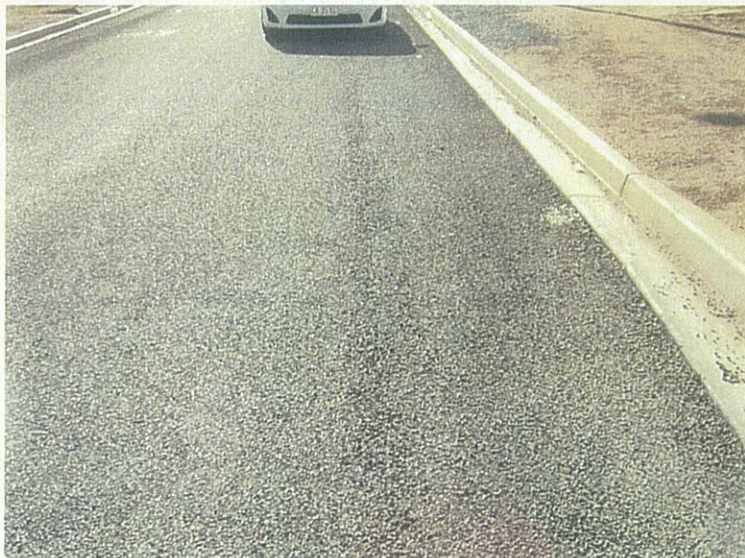
Minor localised stripping possibly due to partially blocked sprayer jet
